# AAIB Bulletin S1/2024

## *SPECIAL*

### Serious Incident

| <b>Aircraft Type and Registration:</b> | Boeing 737-8K5, G-FDZS | |

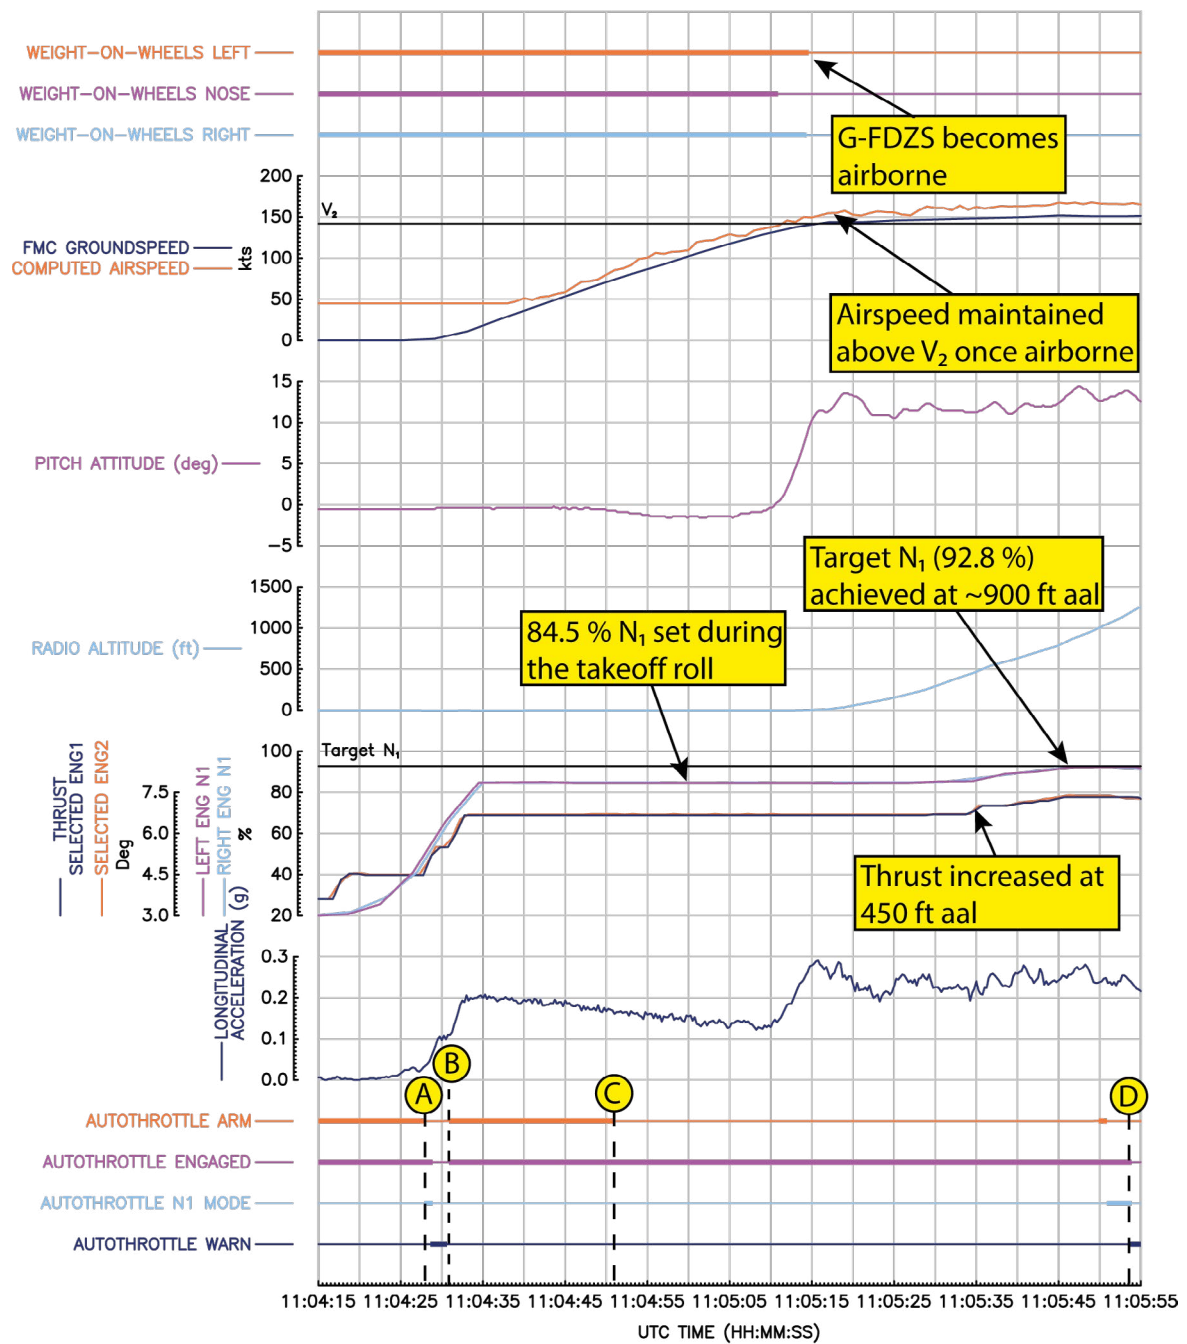
**Figure 1**  
FDR data for the takeoff

- (A) A/T transitions from ARM to N1 mode on TOGA selection, disconnects almost immediately with a warning
- (B) A/T re-armed within five seconds but no active mode selected
- (C) A/T transitions to ARM HOLD mode, as per design, at 84 kt
- (D) A/T transitions from ARM to N1 mode, but disconnects with a warning almost immediately (2nd uncommanded disconnect)

The data shows that 84.5%  $N_1$  was set for the takeoff instead of 92.8%  $N_1$  and, although the thrust setting was increased from 450 ft aal, the required takeoff thrust setting was not attained until passing approximately 900 ft aal. As a result, G-FDZS became airborne 260 m from the end of Runway 09 and the runway end was overflowed at a height of approximately 10 ft. Further, as the correct thrust setting was not set until passing approximately 900 ft aal, the A38 road, adjacent to the boundary of Bristol Airport, was overflowed at less than 100 ft.

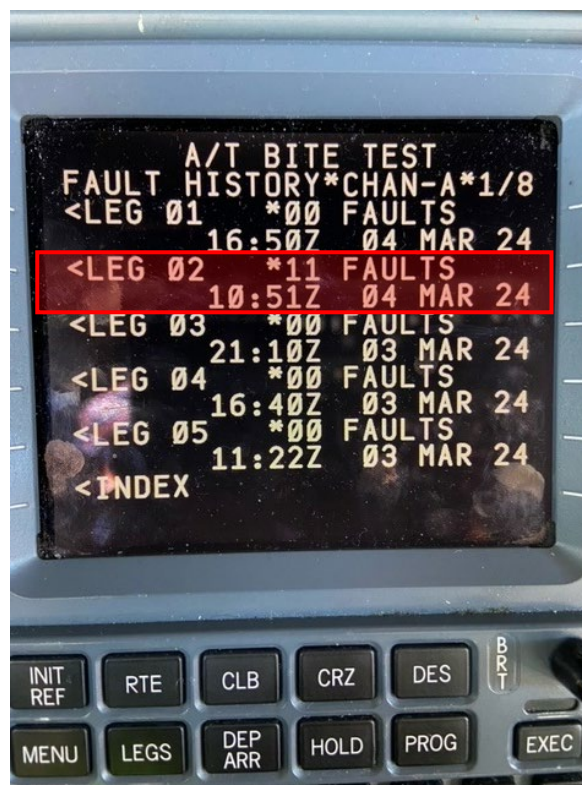
**Figure 2**

The MCDU allows maintenance personnel to interrogate the health of several aircraft subsystems, including the A/T, and to investigate any logged faults. The fault history for the A/T, (Figure 2), shows that 11 faults were logged for the incident flight to Las Palmas - LEG 02 - but no faults were logged on the return flight to the UK, or on the preceding day.

A/T fault history for the incident flight and the preceding day

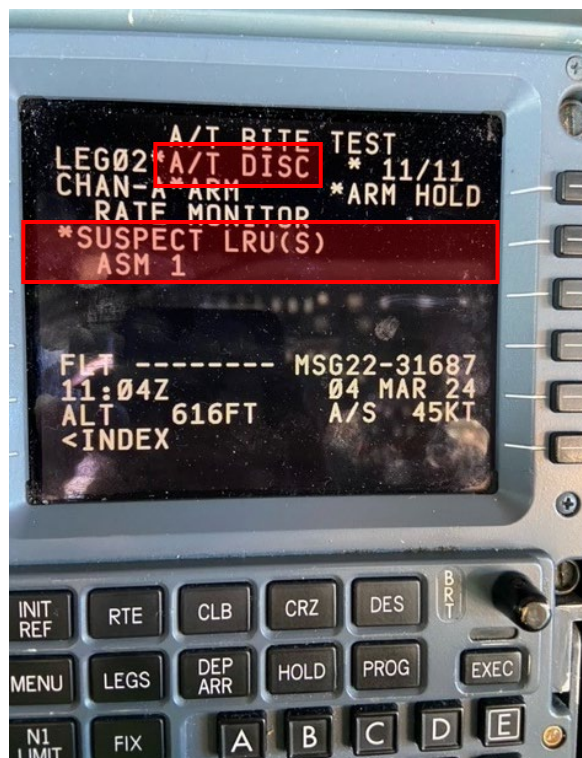
**Figure 3**

Detailed fault record for the initial uncommanded A/T disconnection, showing the suspected cause as ASM 1

The fault record indicates the suspected cause of the uncommanded A/T disconnection as ASM 1, the A/T servo motor for the number 1 engine throttle lever. A further four uncommanded A/T disconnections occurred during the flight to Las Palmas, two during the initial climb to altitude and two during the cruise. A series of other fault messages were logged, after the initial A/T disconnection, as G-FDZS accelerated for takeoff. These were generated passing 90 kt airspeed and all related to the mis-set thrust, indicating that the correct takeoff thrust had not yet been set.

The manufacturer described the A/T system on the 737NG as having a long history of nuisance disconnects during takeoff mode engagements. When the fault history of the A/T is checked they often show fault messages for the autothrottle servo motor (ASM) for either throttle lever 1 or 2. Usually, subsequent functionality checks on the system find no faults. Investigations by the aircraft manufacturer together with the manufacturer of the ASM found that an earlier model of the motor was more susceptible to power on or power transfer events which can cause the ASM to shut down internally and cause a disconnect of the A/T when the TOGA switch is pressed.

A newer model of the ASM is more robust to the power quality issues associated with power on and power transfer events and the manufacturer recommends that any operators of the 737NG who are affected by these disconnects should retrofit their aircraft with the newer model of ASM and associated Flight Control Computer software. The manufacturer released a Fleet Team Digest in October 2021 detailing the issue and the available service bulletin (SB) for replacement. At the time of this event G-FDZS was fitted with the earlier model of ASMs.

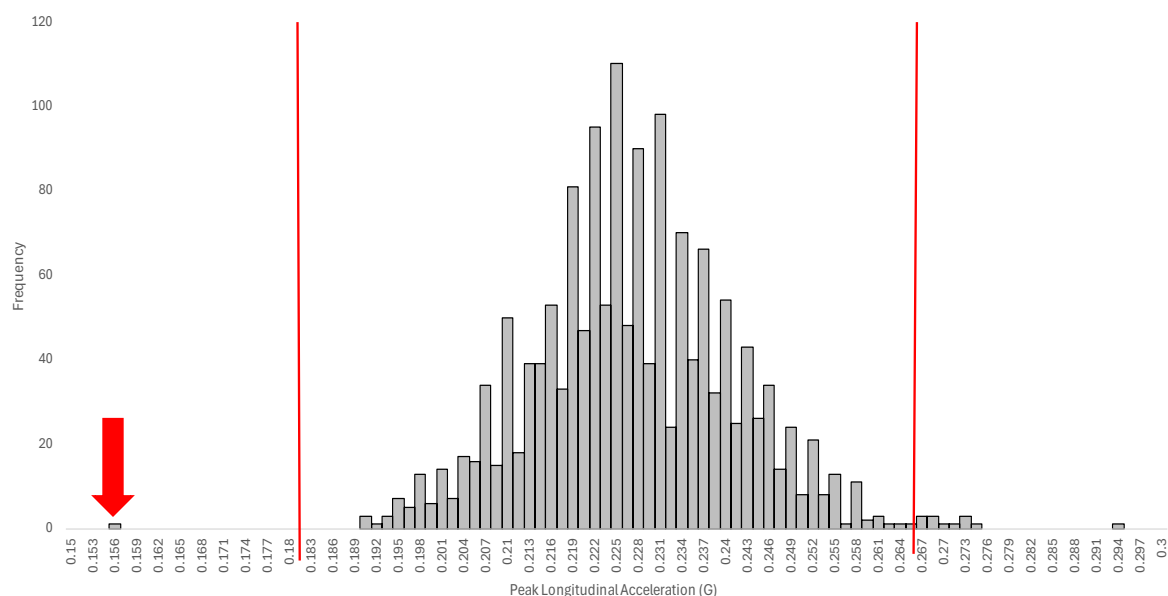
**Figure 4**

Although this event was reported, the operator conducted a retrospective analysis using a simple statistical measure of other 737 takeoffs from Bristol and produced the plot shown in Figure 4. The X-axis represents the peak longitudinal acceleration at around 80 kt groundspeed and the Y-axis the number of takeoffs that are represented by each bar. The incident takeoff is shown by the red arrow in Figure 4, far to the left of the bulk of the data, whereas for a normal distribution of data 99.7% of all takeoffs would be expected to lie within the region marked by the two vertical red lines.

Histogram of 737 takeoffs at Bristol,  
showing the normal spread of peak accelerations and the incident takeoff
