# Rail Accident Report

## **Derailment of a passenger train at Grange-over-Sands, Cumbria 22 March 2024**

Report 02/2025  
January 2025

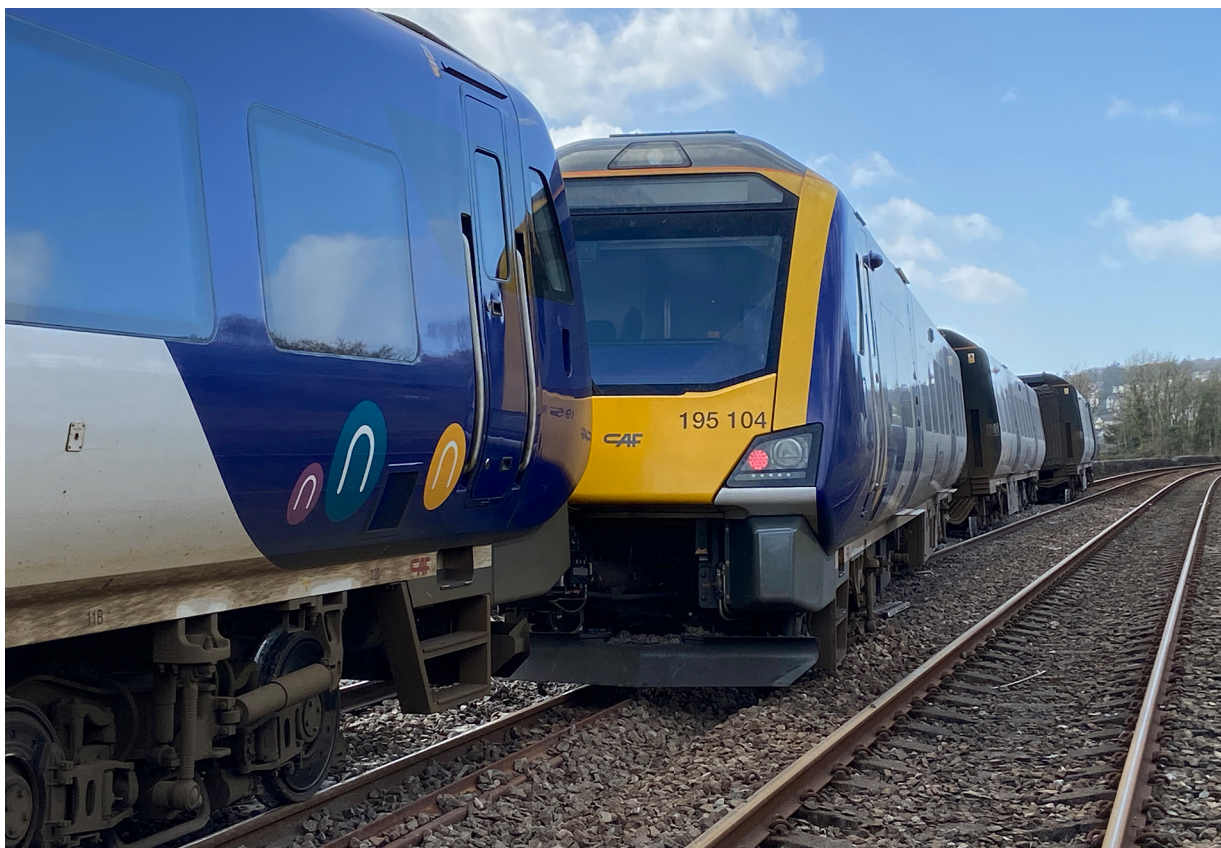
- 21 The train which derailed in the accident (figure 4), reporting number 2C37, was the 05:18 passenger service from Preston to Barrow-in-Furness. The train was the first service to pass through the area of the embankment damage (on either line) on the morning of the derailment. Train 2C37 was made up of two 3-car class 195 units coupled together, making a total of six vehicles. Class 195 trains are a type of diesel multiple unit from the Civity family. It was manufactured by CAF and is owned by Eversholt Rail Leasing Ltd. The train was fitted with an on-train data recorder (OTDR) and forward-facing, rear-facing, and bodyside mounted closed-circuit television (CCTV) systems.

Figure 4: Train 2C37 following the derailment.

- 76 During the derailment, the train sideswiped the parapet wall on the seaward side of the embankment, knocking masonry down onto the beach and causing significant damage to the train. During this collision, the train lost power to its leading cab. This affected safety systems such as the GSM-R radio and the headlights, which immediately went out.

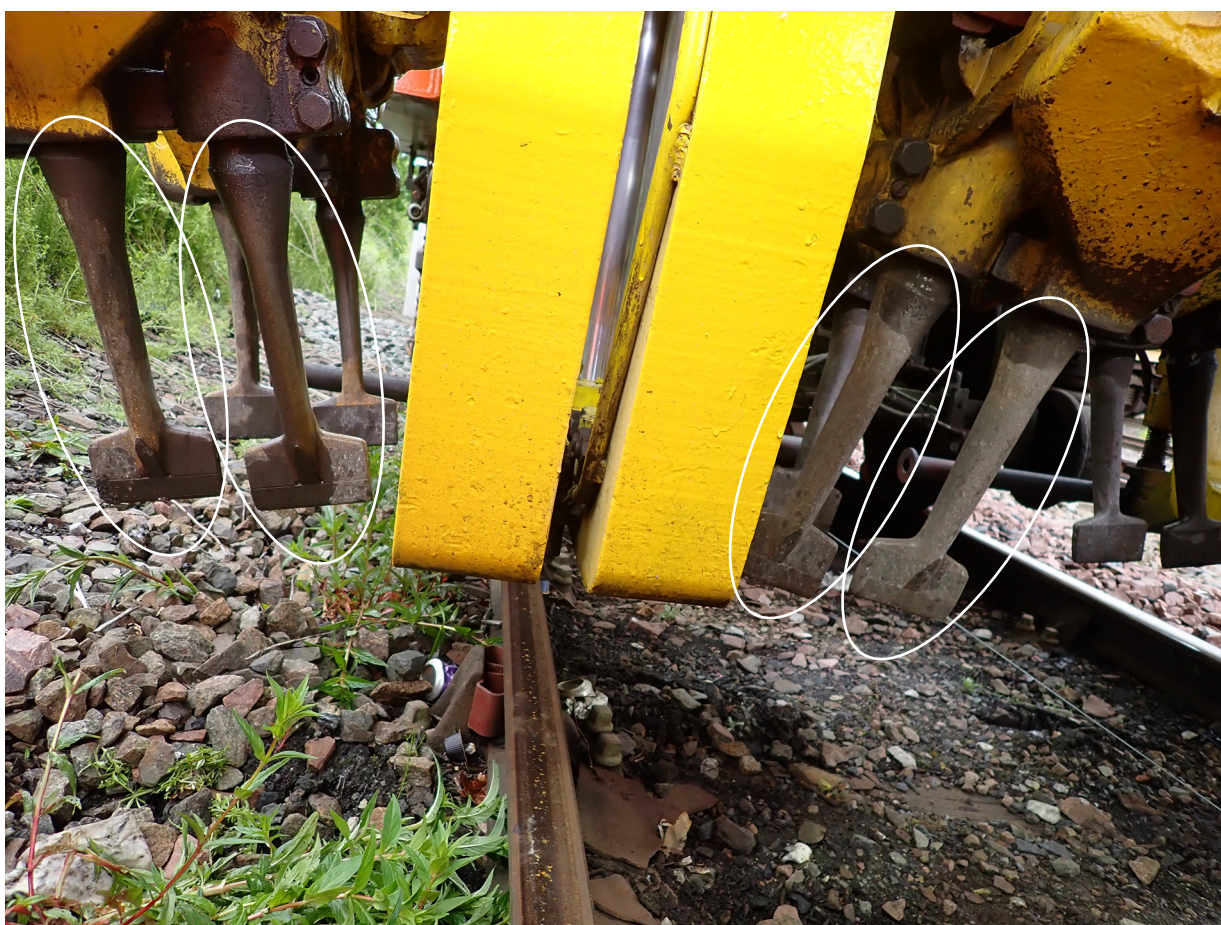
Figure 5: Tamper tines (circled) on the tamper involved in the accident.

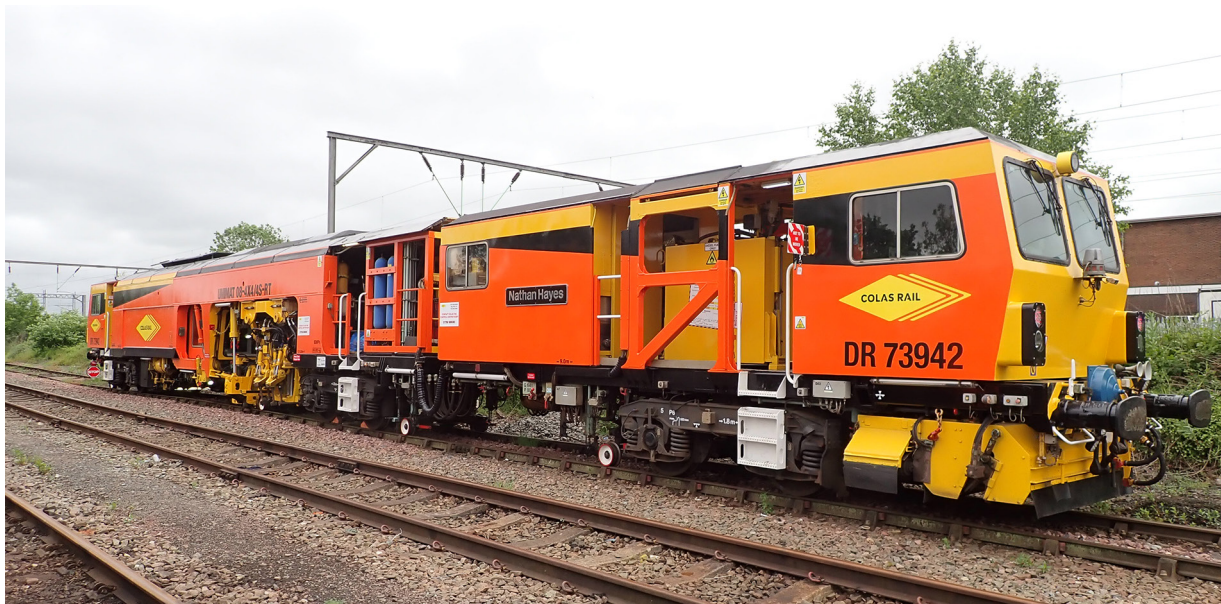
- 24 The tamper which struck the pipe, train reporting number 6J87, was being used for routine track maintenance (figure 6). This tamper requires a three-person crew to operate it, comprising of one supervisor and two operatives. The OTM supervisor sits in the cab of the machine looking in the direction of travel. The operatives sit in the middle of the machine facing backwards and operate its tines. This tamper is also fitted with a welfare area, for staff not directly involved in the tamping operation and for the crew to take breaks.

Figure 6: Tamper 6J87 which struck the pipe.

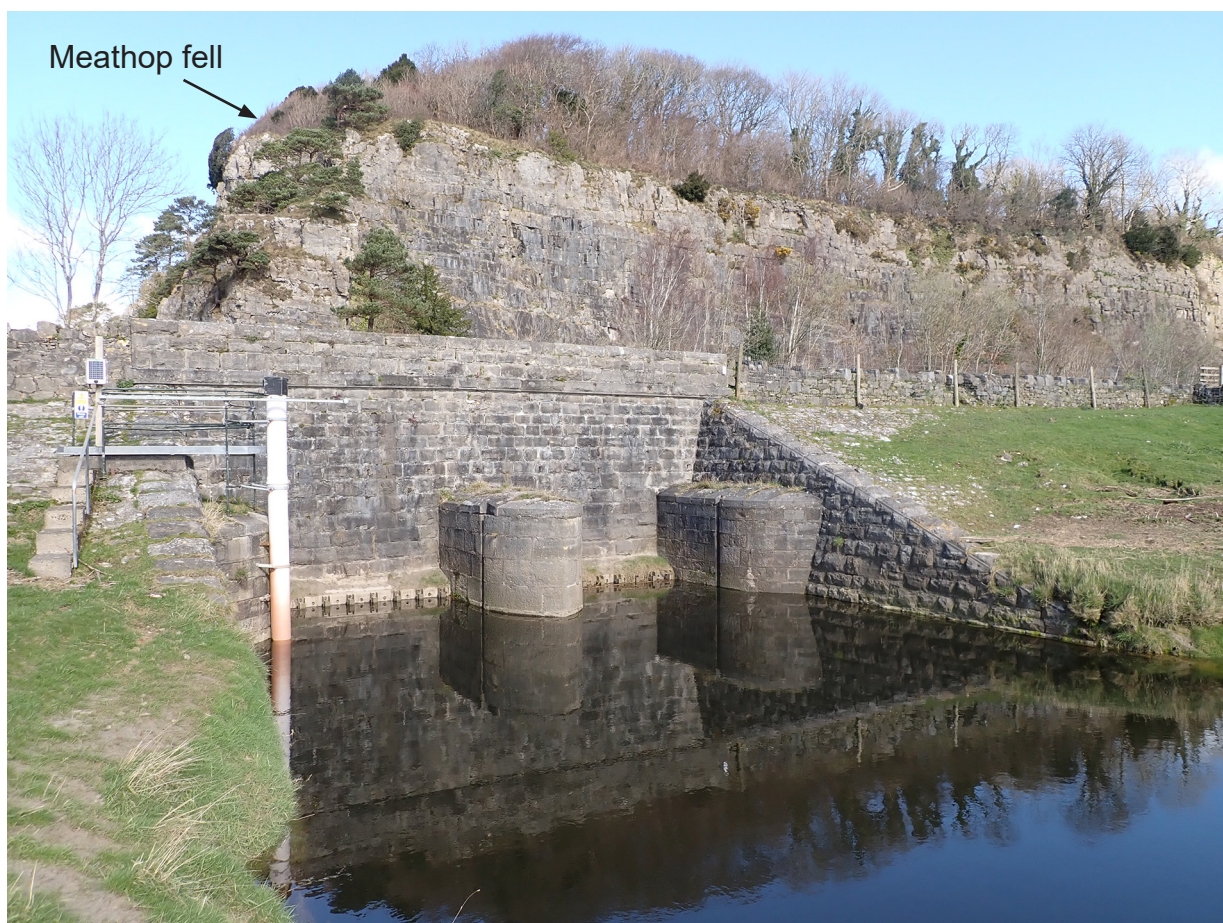
Figure 7: Tidal gates on the River Winster.

- 52 Due to damage to one of the tidal gate's hinges, and in an attempt to resolve the issue with flooding, Network Rail replaced the River Winster gates in 2017/18.

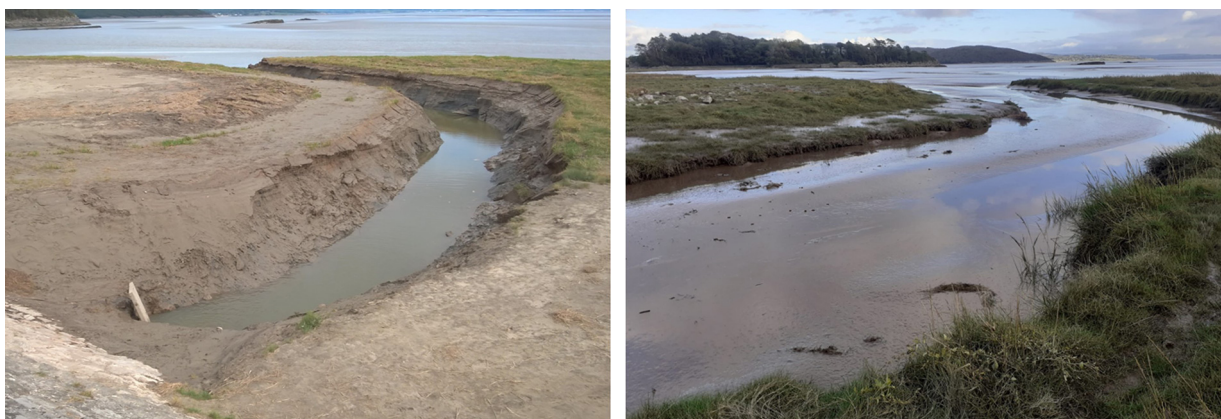
- 53 In 2020, the golf club funded an excavation of the outlet at Seldom Seen culvert under a licence issued by the council. A 70-metre channel was created from the outlet and the culvert was cleared of sediment by golf club contractors. The golf club contractors also fitted a new non-return valve to the seaward side of the culvert, and a metal grill on the landward side to protect the culvert from becoming blocked again. This excavation was effective in discharging water over the summer months, but by autumn/winter 2020 the channel had blocked up again (figure 8). This was similar to the experience of those trying to maintain the channel in the 1950s/60s (paragraph 38).

*Figure 8: The outfall to Seldom Seen culvert pictured 3 to 4 months apart around May to September 2020 (courtesy of Westmorland and Furness Council).*

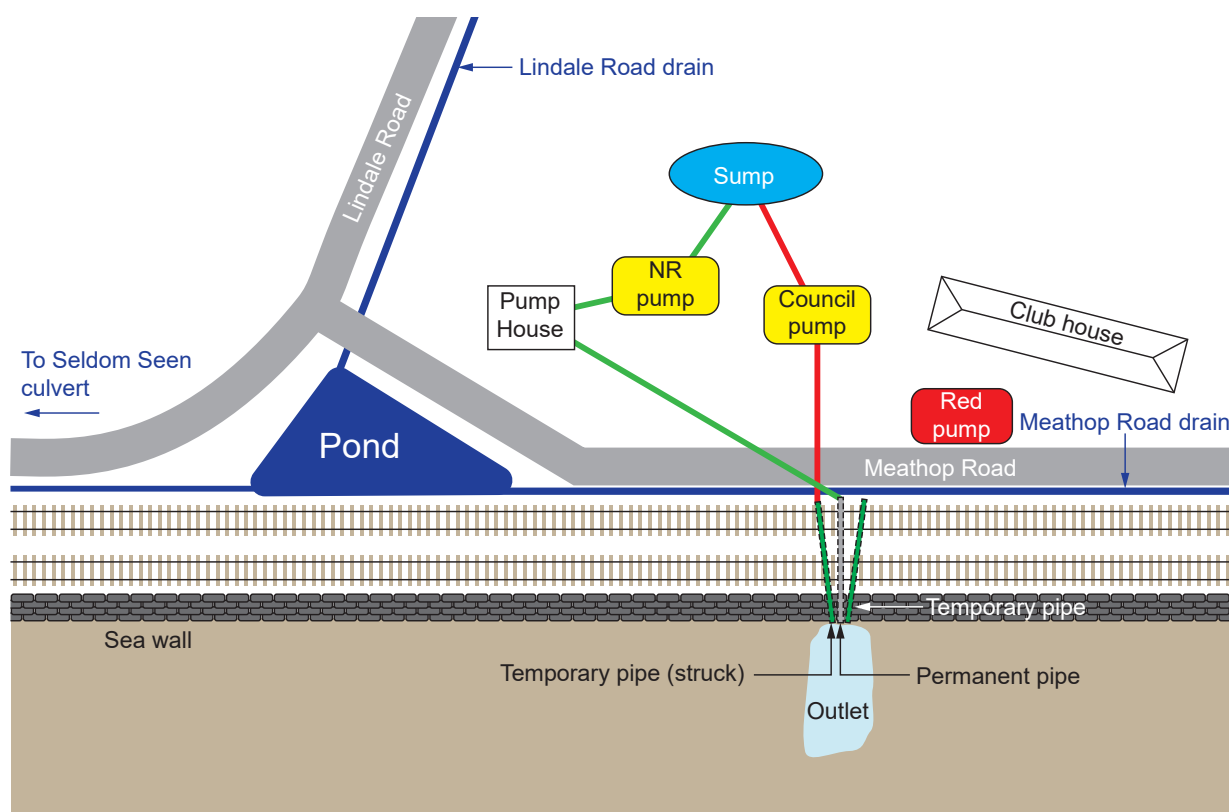
- A diesel pump provided by the council (paragraph 60) which was connected to the first temporary pipe installed by Network Rail. This was the pipe that was damaged by the railway maintenance activity (paragraph 5). The consequent leak created the void that led to the accident (see paragraph 115).

Figure 9: The pipe and pump arrangements at the golf club as discovered immediately after the accident.

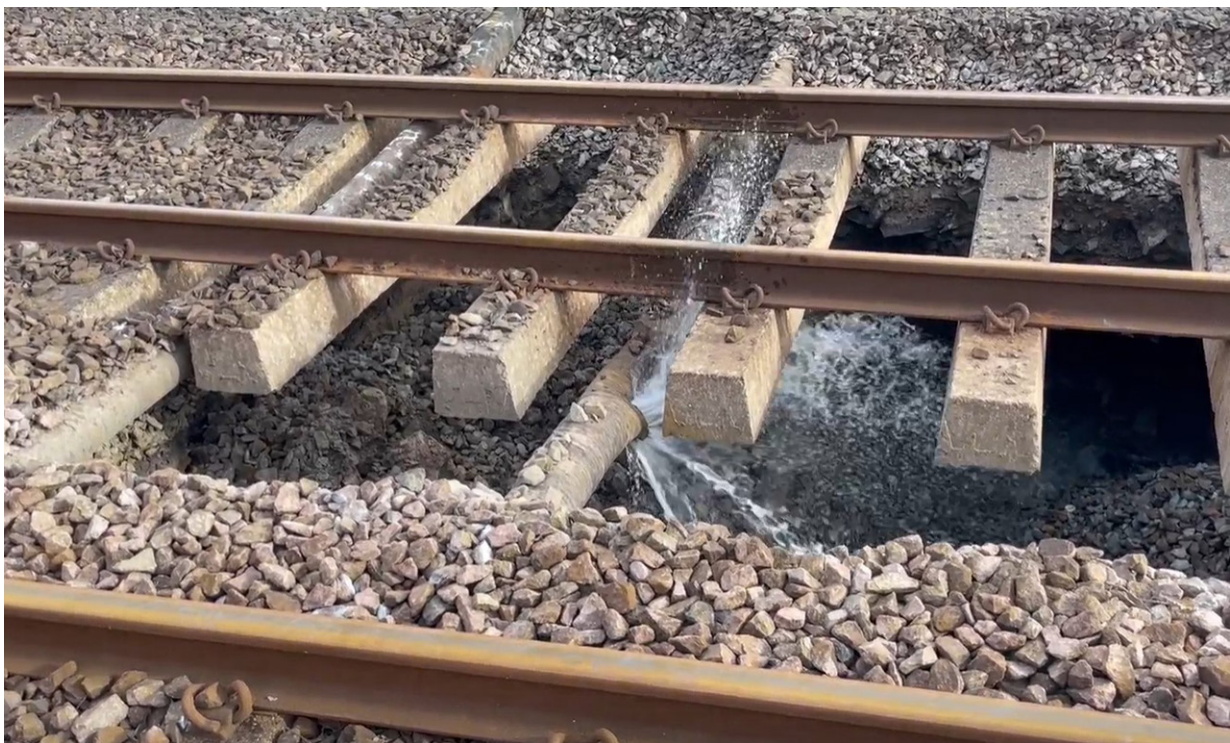
- Site of special scientific interest (SSSI): this designation is awarded to sites that are of particular interest to science due to the rare species they contain.

- Special area for conservation (SAC): this designation protects one or more habitats and/or species.
  - Special protection area (SPA): this designation protects habitats for birds.

Figure 11: Water being sprayed from the damaged pipe during a site test.

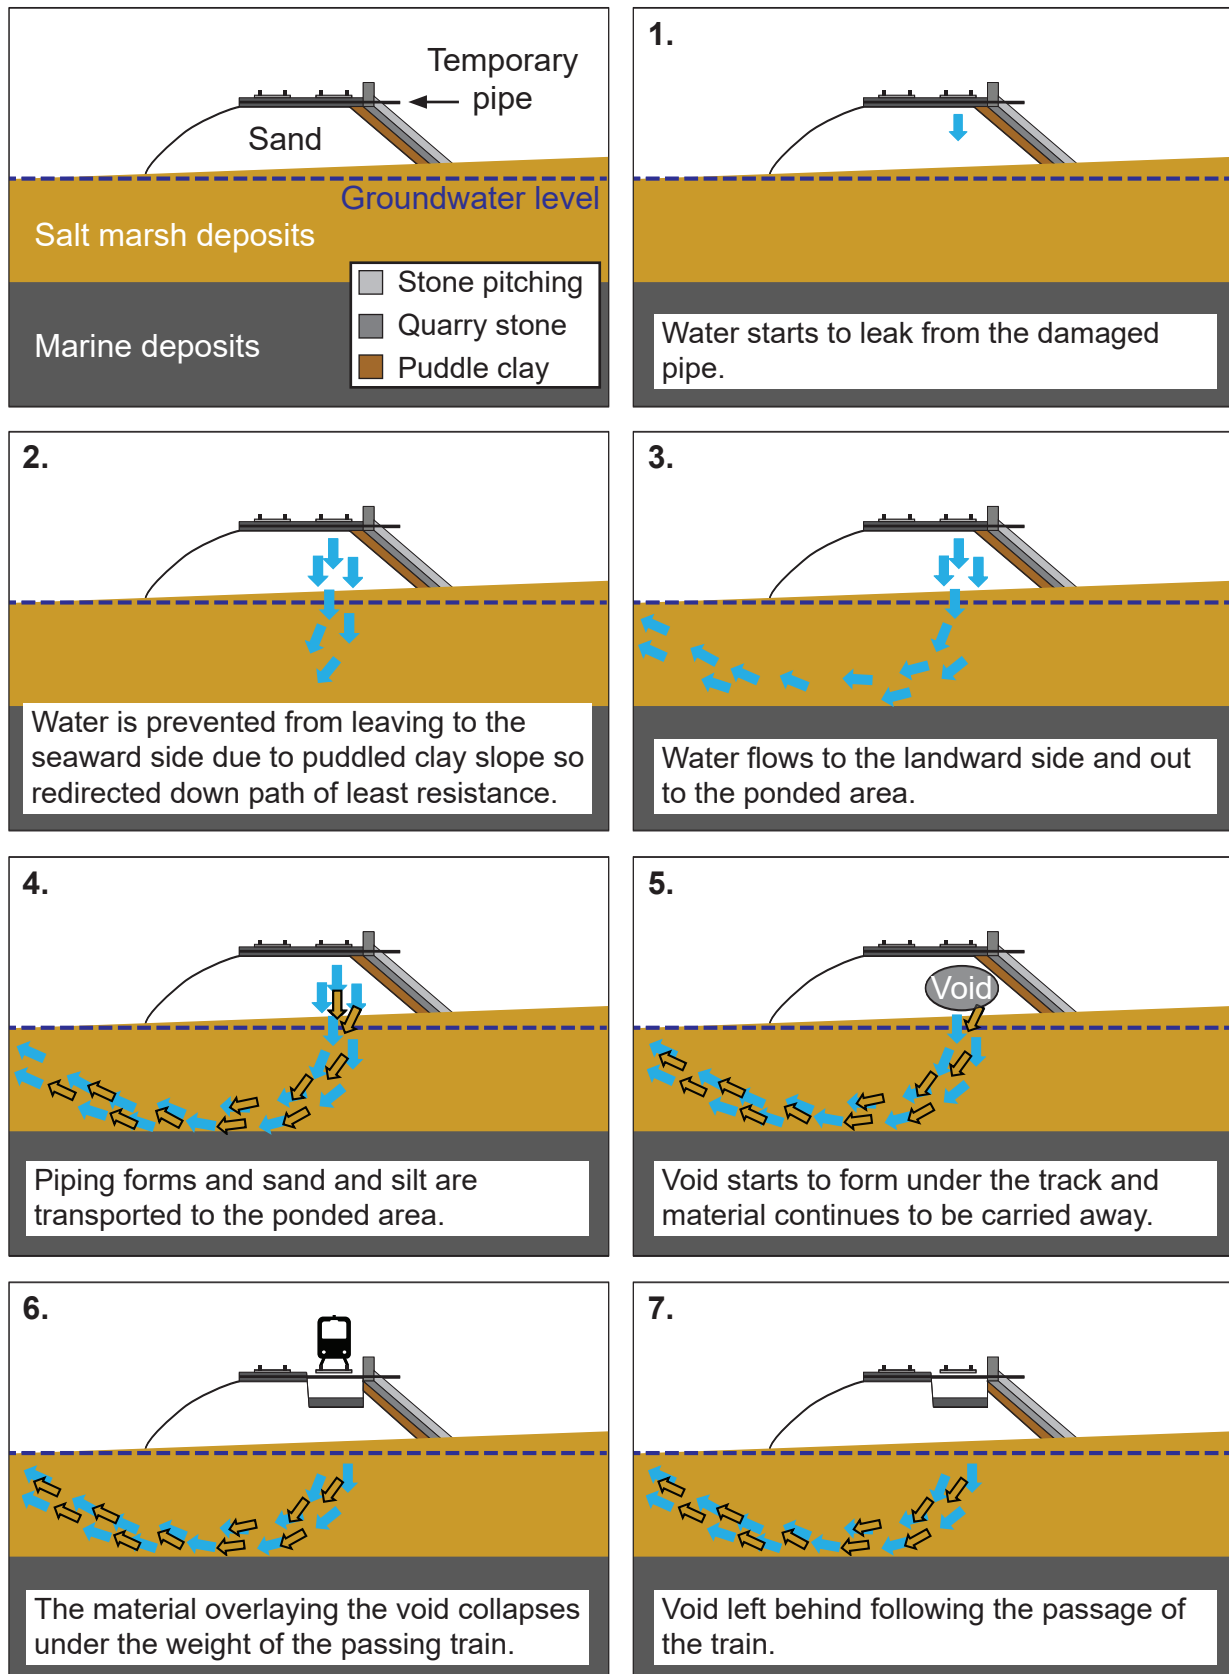
### Organisations involved

- 12 Network Rail owns, maintains, and operates the railway infrastructure in the Grange-over-Sands area, which is on its North West route. This route is part of Network Rail's North West and Central region. Network Rail also employs the track maintenance workers, engineers, controllers, and signallers involved in the accident.

Figure 12: How soil piping affected the embankment.

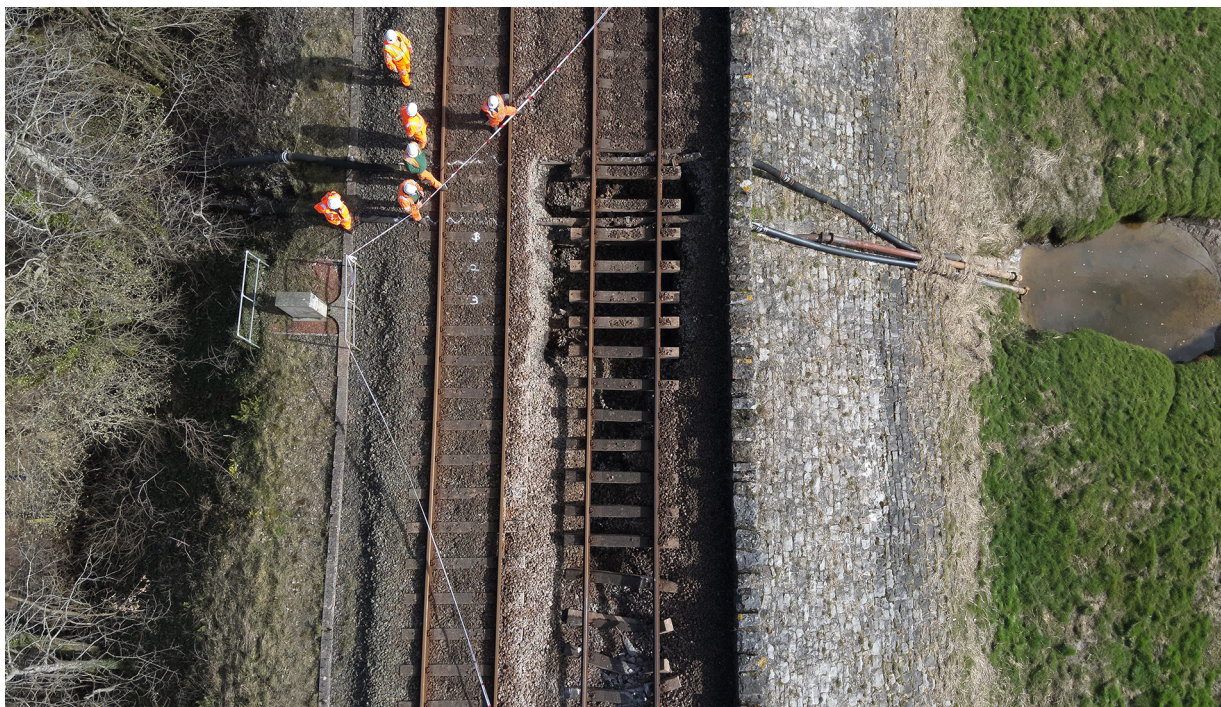
Figure 14: Overview of the site captured by a drone showing the adjacent line marked with a 3-2-1 countdown (courtesy of Network Rail).

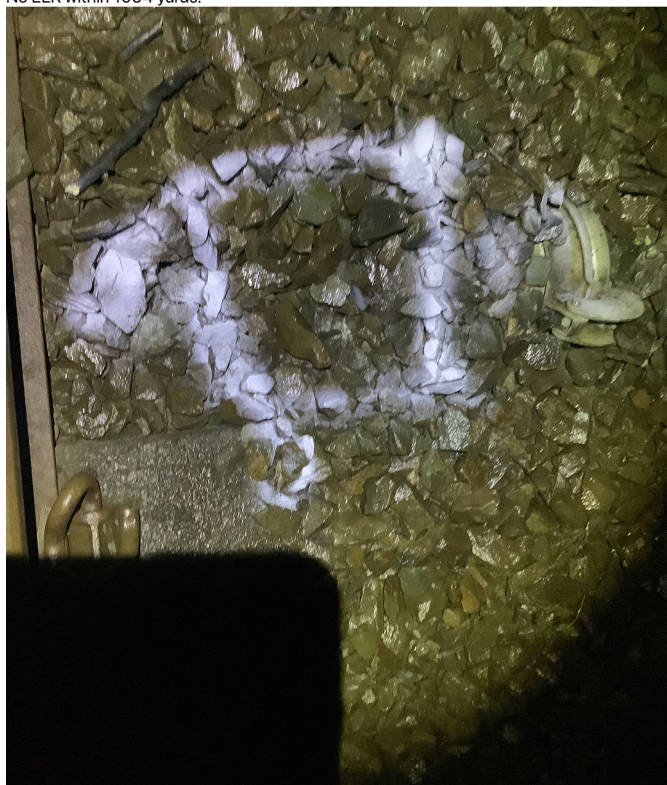
- 27 There were two drivers in the leading cab of train 2C37 during the accident, a trainee and an instructor. The trainee driver was at the controls of the train during the derailment. The trainee driver starting driving trains in November 2023 and had previously completed trips over this route with a different instructor. The instructor driver had 5 years' experience driving trains, always with Northern, and had qualified as an instructor shortly before the accident. The way in which the train was driven had no bearing on the accident.

*Figure 15: The pipe after it had been struck by the tamper. This is the image that was provided to the IC at Manchester ROC (courtesy of Network Rail).*

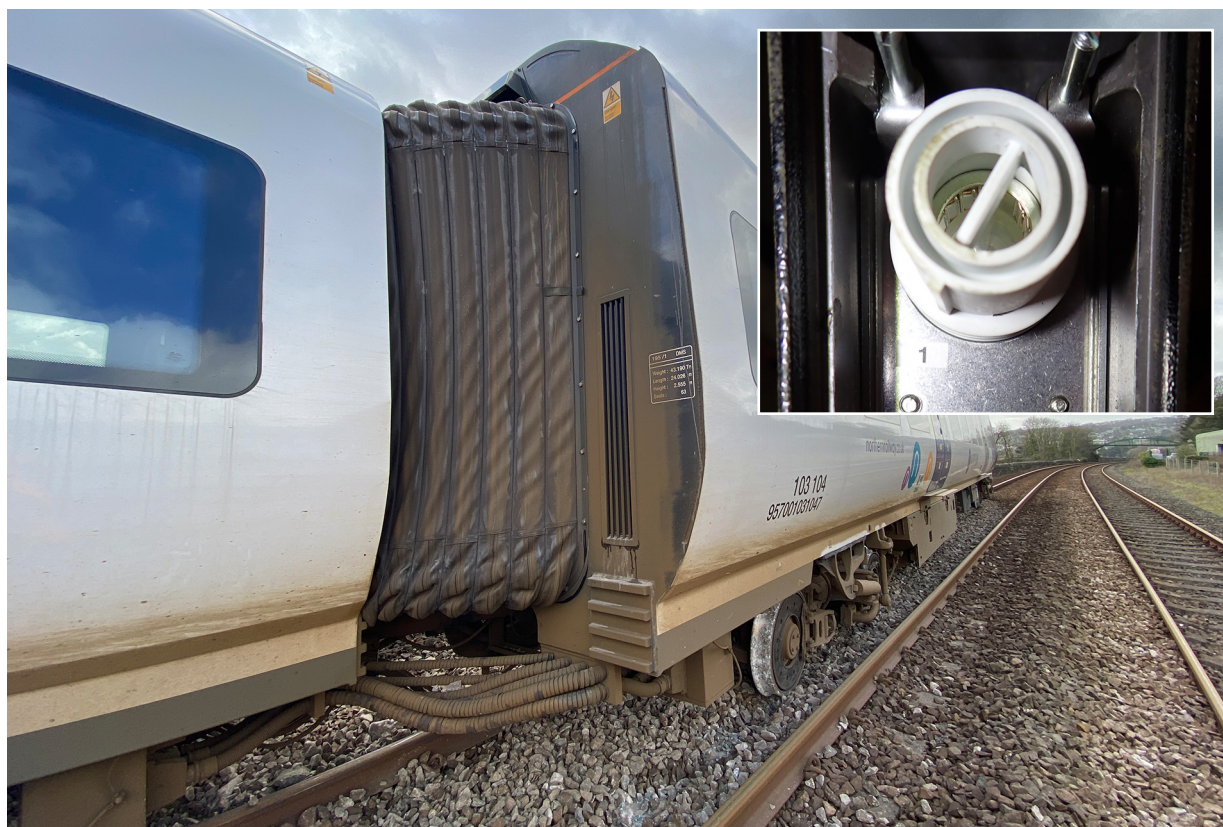
Figure 16: The power transfer cable stretched taut following the derailment (main). Damage to the internal fittings of the power cable discovered post derailment (inset).

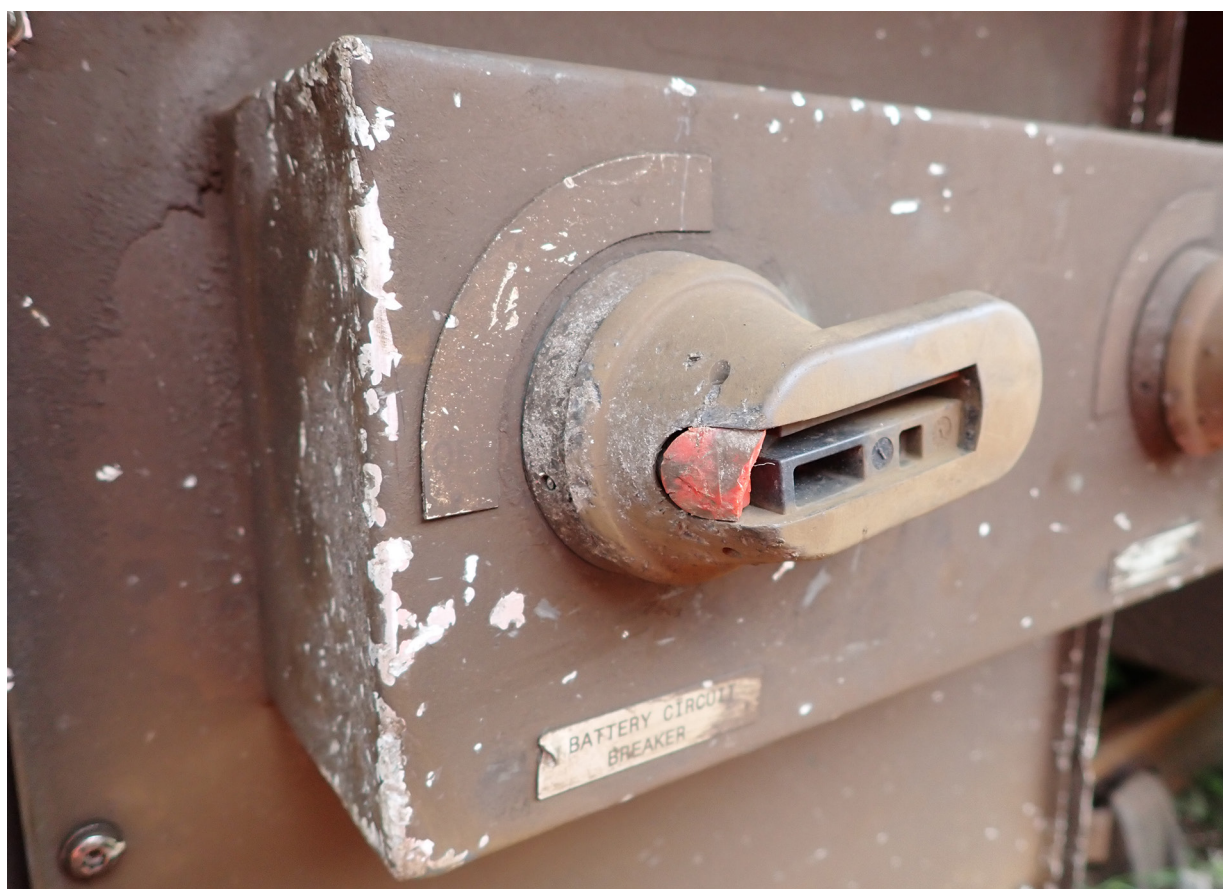
Figure 17: Damage caused to the battery isolation switch as it was knocked to the isolated position during the derailment.
