# Rail Accident Report

## **Derailment of a passenger train near Walton-on-Thames, Surrey 4 March 2024**

Report 04/2025  
February 2025

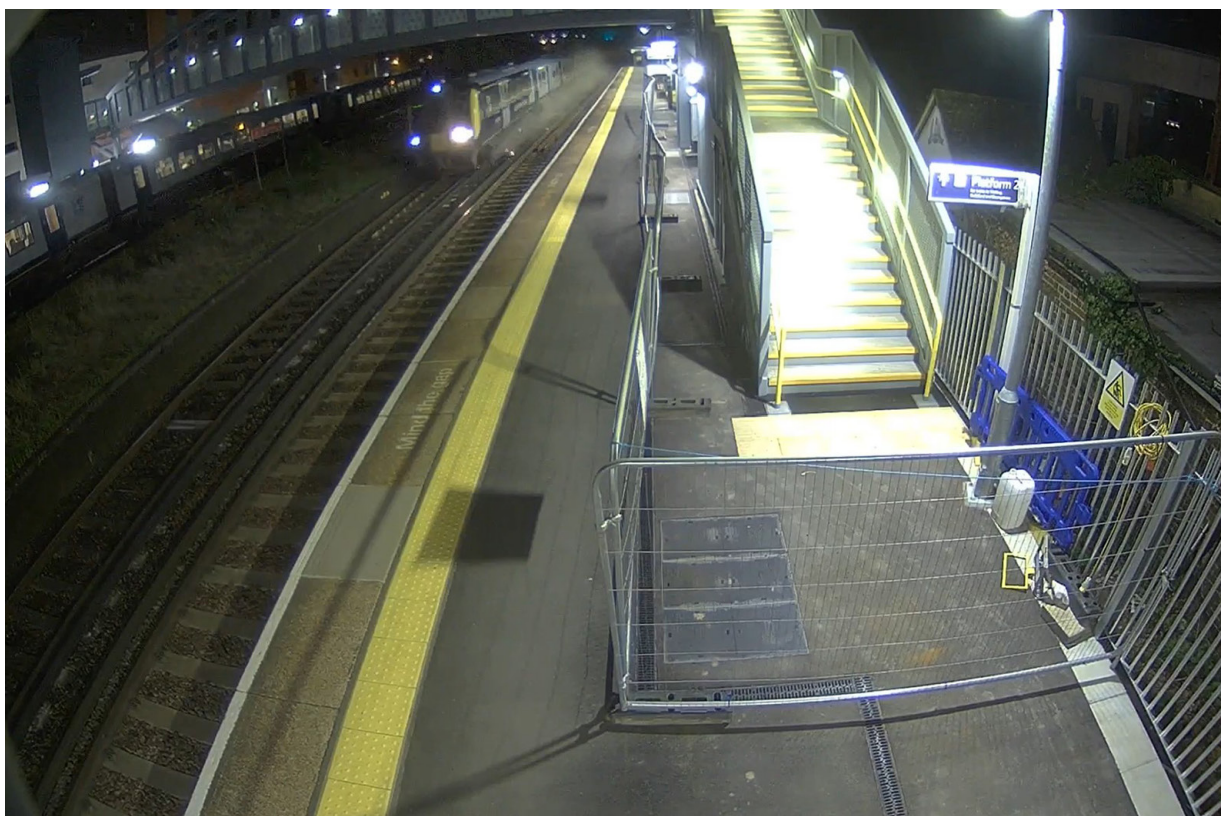
- 3 At around 05:40 on Monday 4 March 2024, train reporting number 2L10, the 04:54 South Western Railway passenger service from Basingstoke to Waterloo, struck a 2.5 metre section of redundant rail. This occurred on a road-rail vehicle access point (RRAP) on the approach to Walton-on-Thames station. At the time, the train was travelling at around 85 mph (137 km/h). The leading wheelset derailed to the left, but the train remained upright and came to a stand around 500 metres beyond the point of collision (figure 1).

*Figure 1: Image from Walton-on-Thames station CCTV showing train 2L10 running derailed as it passed the out-of-use platform at Walton-on-Thames station (courtesy of South Western Railway).*

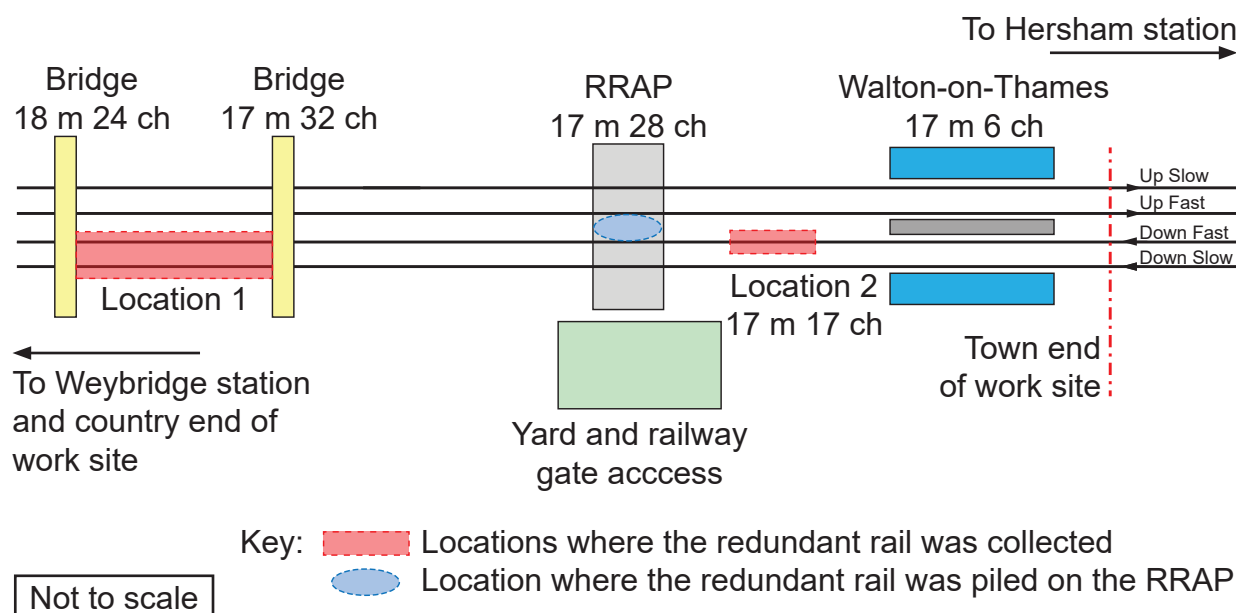
- 41 After the RRV was off-tracked and the other redundant material had been deposited in the yard, the RRV was on-tracked on the Down Fast line and moved to location 2 without the trailer. The RRV was then used to collect the cut sections of redundant rail from the four-foot of the Down Fast line and the ten-foot (the space between two pairs of running lines) using the log grab. The redundant rail was placed in a pile on the RRAP.

Figure 8: Diagram of work site, showing the approximate locations where the redundant rail was collected (red shaded rectangle area) and piled on the RRAP (blue shaded oval area) during the morning shift at the work site near Walton-on-Thames station.

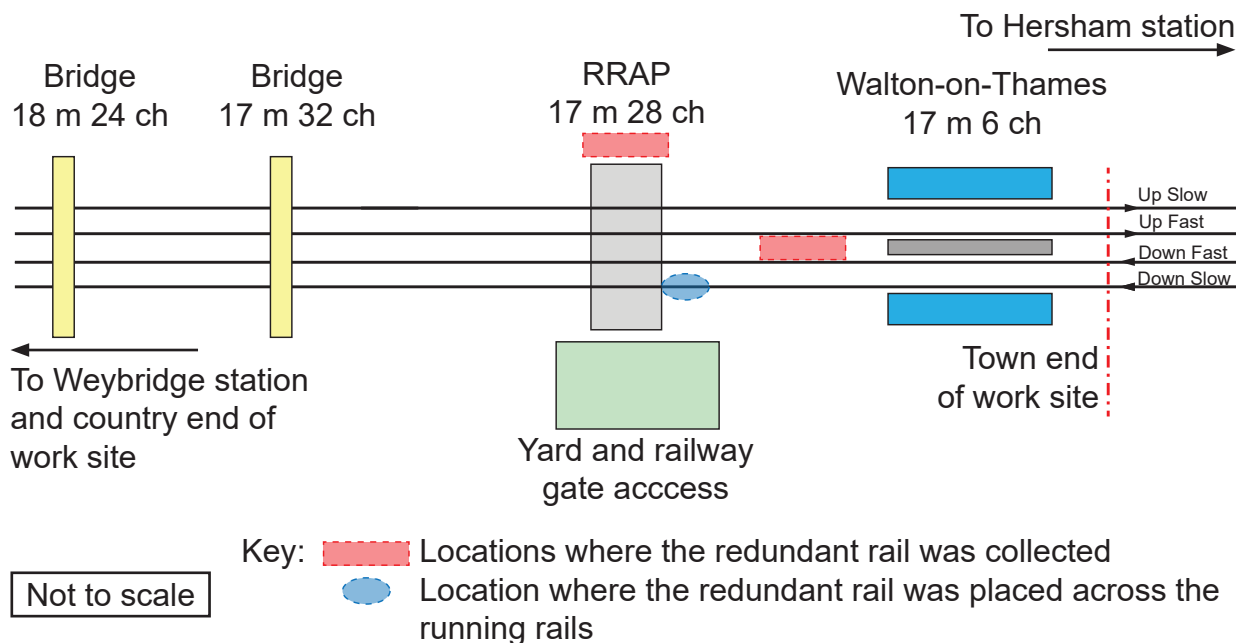
- 45 At around 15:00, the site supervisor instructed the machine operator and machine controller to connect a brush to the RRV to clear the ballast from the flangeways (the gap between the running rail and the surface of the RRAP) of the Down Slow and Down Fast lines within the RRAP. TL2 was also instructed to supervise this by the site supervisor. At around 16:00 TL2 inspected the RRAP flangeways. TL2 stated that, after they inspected the flangeways, they looked across the RRAP in daylight and could see no redundant rail near the RRAP at this point. After the inspection of the flangeways, the RRV brushed the Down Slow line in the down direction (moving towards the country end of the work site).

Figure 9: Diagram of work site, showing the approximate locations where the redundant rail was collected (red shaded rectangle areas) and placed on the railhead (blue shaded oval area) during the evening shift at the work site near Walton-on-Thames station.

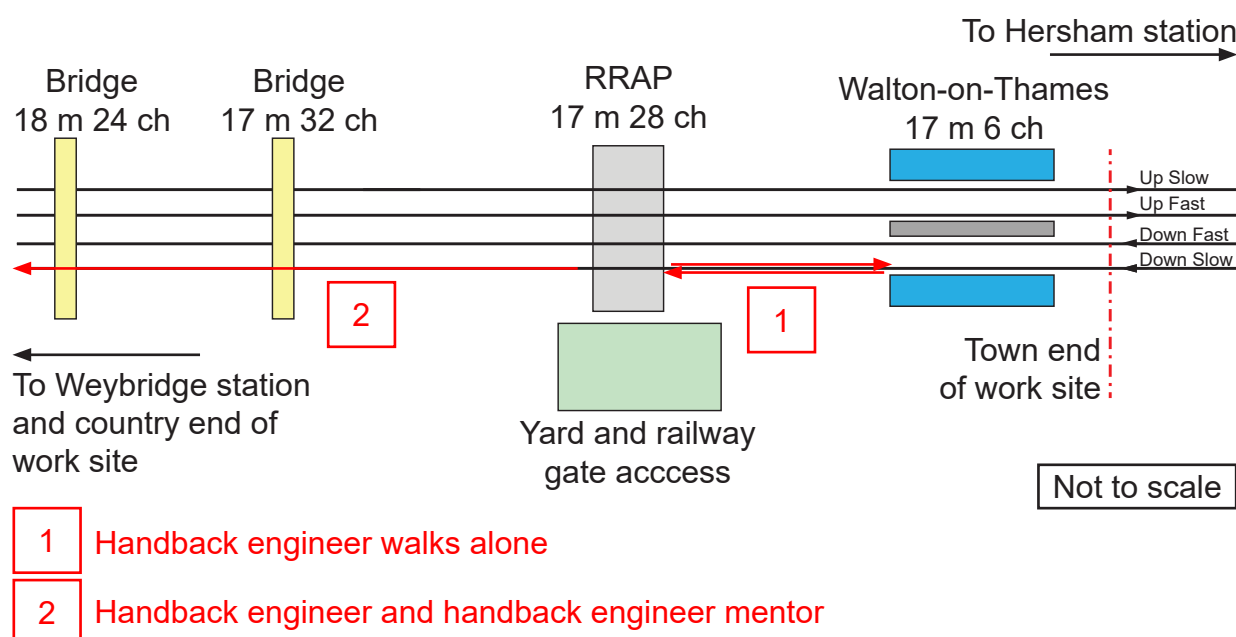
- 51 After this briefing, the handback engineer began the inspection, walking from the RRAP to the town end of the work site, near to Walton-on-Thames station (figure 10). Witness evidence shows that the handback engineer undertook this visual inspection walking in the four-foot of the Down Slow line to check the track geometry. In parallel, the handback engineer also looked for redundant rail in the Down Slow line and looked across to the Down Fast line for any redundant rail that had been left foul of the running line. Witness evidence also shows that this part of the inspection was completed without the handback engineer mentor being present and that the handback engineer used a handheld torch to illuminate the track around them (see paragraph 156).

Figure 10: Diagram of work site, showing the routes walked by the handback engineer and handback engineer mentor from 23:00 on 2 March.

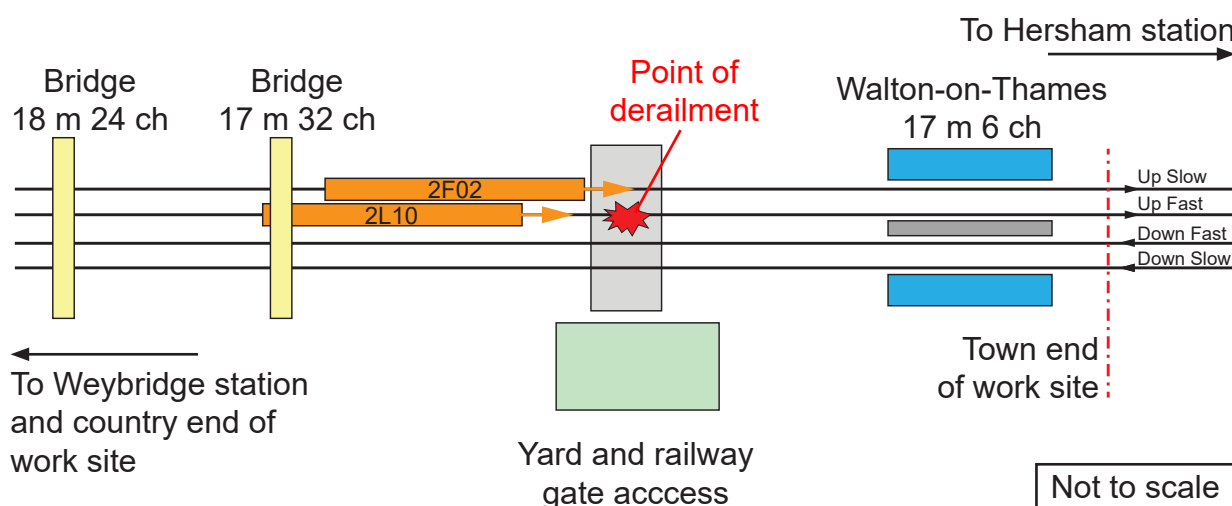
- 58 At around 05:37, train 2L10 approached the RRAP travelling at around 85 mph (137 km/h) on the Up Fast line. It struck a section of scrap rail on the RRAP and the train's leading wheelset derailed to the left (see figure 11).
- 59 The driver made an emergency brake application between 1 and 2 seconds after the derailment. The train came to a stand, upright, around 500 metres beyond the point of collision.

Figure 11: Diagram of work site, showing the directions of travel of trains 2F02 and 2L10 and the point of derailment of 2L10.

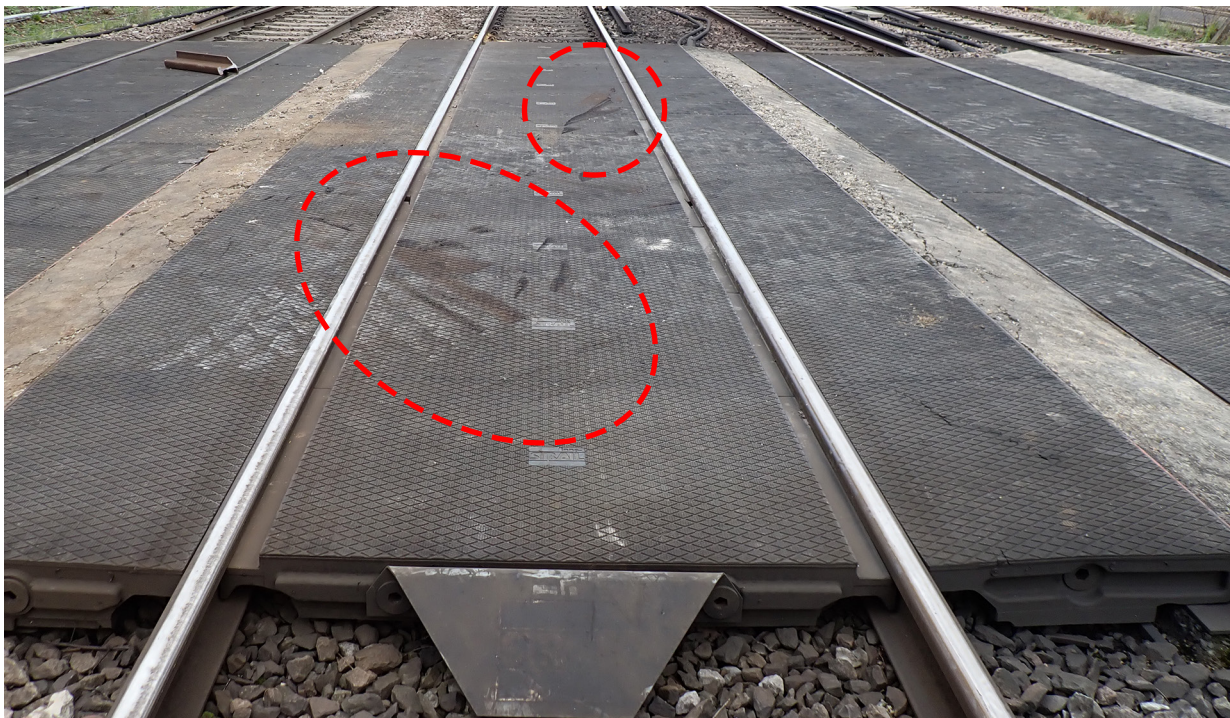
75 While the driver of train 2F02 reported that the object their train struck was sitting on top of the conductor rail on the cess side (the side of the train furthest from the Up Fast line, paragraph 55) the breaking of a bodyside window on the other side of the train, next to the six-foot (paragraph 57) suggests that the collision resulted in the object moving in the direction of the Up Fast line.

*Figure 12: The witness marks (red dashed circles) caused by the section of rail impacting the rubber surface of the RRAP around the Up Fast line. Tyre marks on the RRAP surface, probably caused by the RRV on the 2 March, are also visible on the Up Slow and Up Fast lines.*

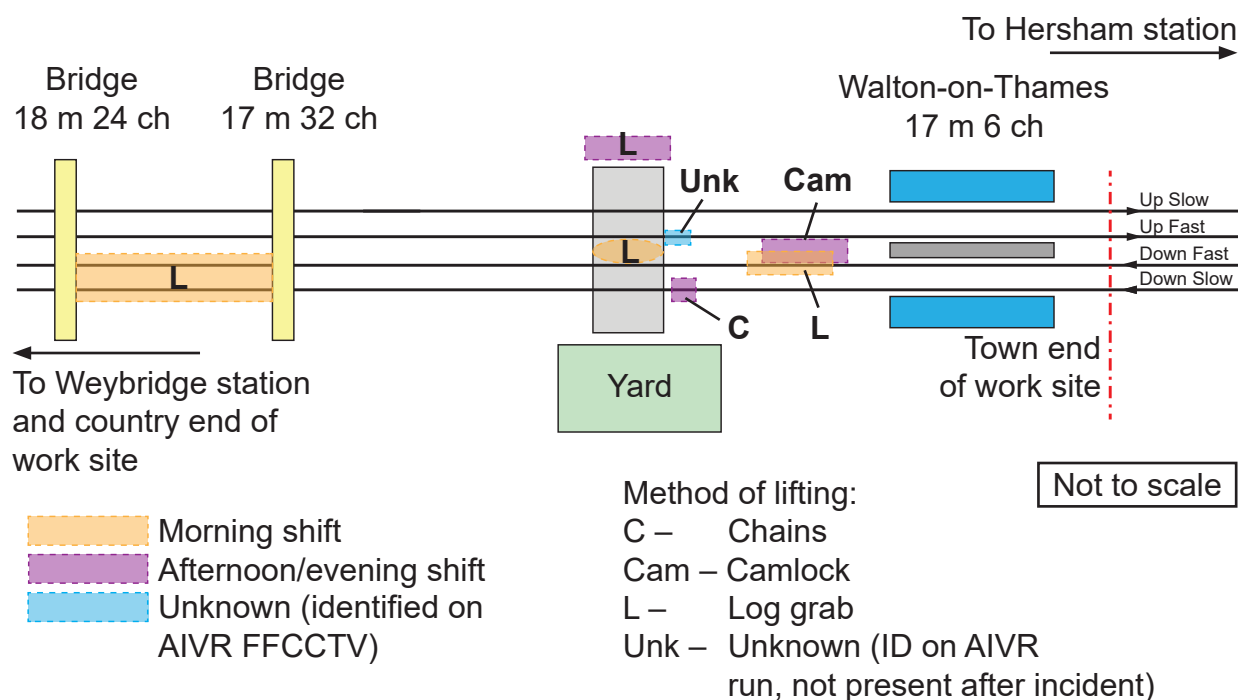
- 83 RAIB has not been able to identify which element of the work undertaken during the weekend of 2 to 3 March 2024 resulted in the redundant rail being left foul of the track. Neither the planning process nor the SWP (see paragraph 116) required a system to record where each section of redundant rail was cut and collected from. RAIB has therefore analysed the tasks that were undertaken at Walton-on-Thames to determine the most likely cause of the section of redundant rail being left on the RRAP.

- 84 FFCCTV from the Automated Intelligent Video Review (AIVR) system shows sections of redundant rail lying near the RRAP in the four-foot of the Up Fast line (figure 14) when a train passed through the location of the work site on 20 February 2024. Network Rail has confirmed that there had been no rail collection at this location between 20 February and 3 March. Post-accident examination of the site showed that this redundant rail was not present, suggesting that it was removed from near the RRAP during the weekend of 3 to 4 March, although such an activity had not been planned and witnesses did not report this work had been completed during the possession.

Figure 14: Diagram of the work site showing the different locations, times and methods of lift used to collect the redundant rail.

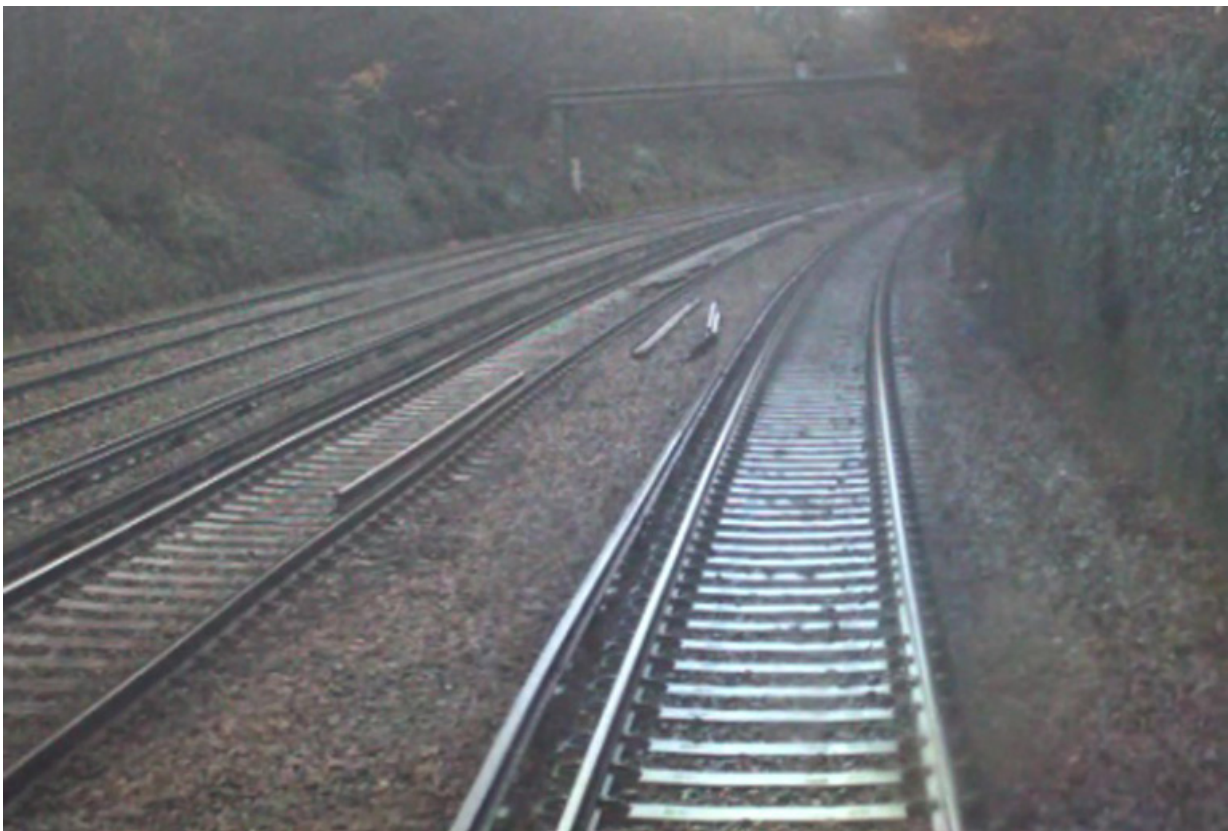
Figure 15: Photo of the FFCCTV from the inspection train used in the email from the project lead to other Colas Rail staff as an 'example of the scrap rail, present in 6ft and adjacent road' (courtesy of Network Rail).

- 113 The email to the site supervisor and handback engineer was ambiguous about which types of rail were to be removed and this may have caused confusion for staff on site as to the intended scope of the work. This is supported by witness and physical evidence that shows both redundant conductor rail and substantial amounts of redundant running rail were removed from several locations in addition to the removal of redundant conductor rail around the Down Slow line. This also affected the handback engineer's understanding of the lines that needed to be checked when the handback inspection was undertaken (paragraph 102).
