# Rail Accident Report

## **Derailment of a passenger train at Grange-over-Sands, Cumbria 22 March 2024**

Report 02/2025  
January 2025

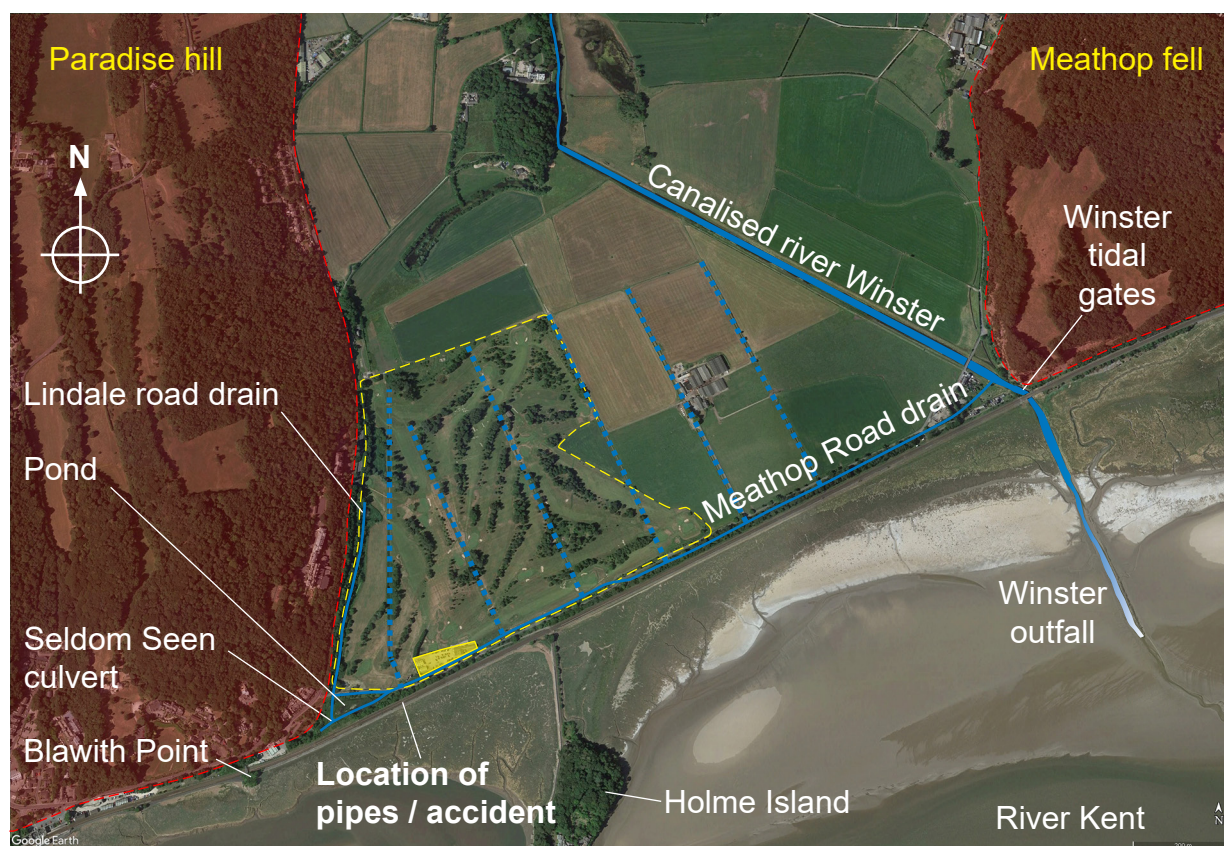
Figure 3: Main features at point of derailment. The golf club is highlighted in yellow, with the club house and car park indicated by a yellow box. The main watercourses are depicted as solid blue lines, with minor water courses shown as dotted blue lines.

- 9 A golf club and several farms are located on land to the north of the railway. The land, bounded by Meathop fell to the east and Paradise hill to the west (figure 3), was reclaimed from the sea as part of the railway's construction in the 1850s (see paragraph 32). Consequently, the land has several drainage features intended to keep it clear of water:
