# Rail Accident Report

## **Derailment of a passenger train near Walton-on-Thames, Surrey 4 March 2024**

Report 04/2025  
February 2025

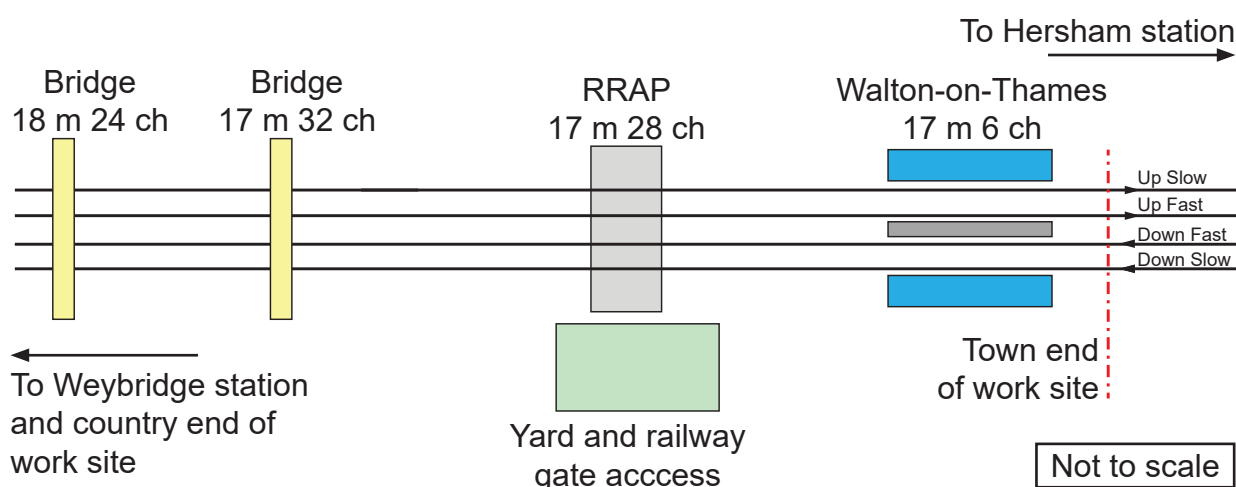
Figure 3: Location of work site, including RRAP and other local features.

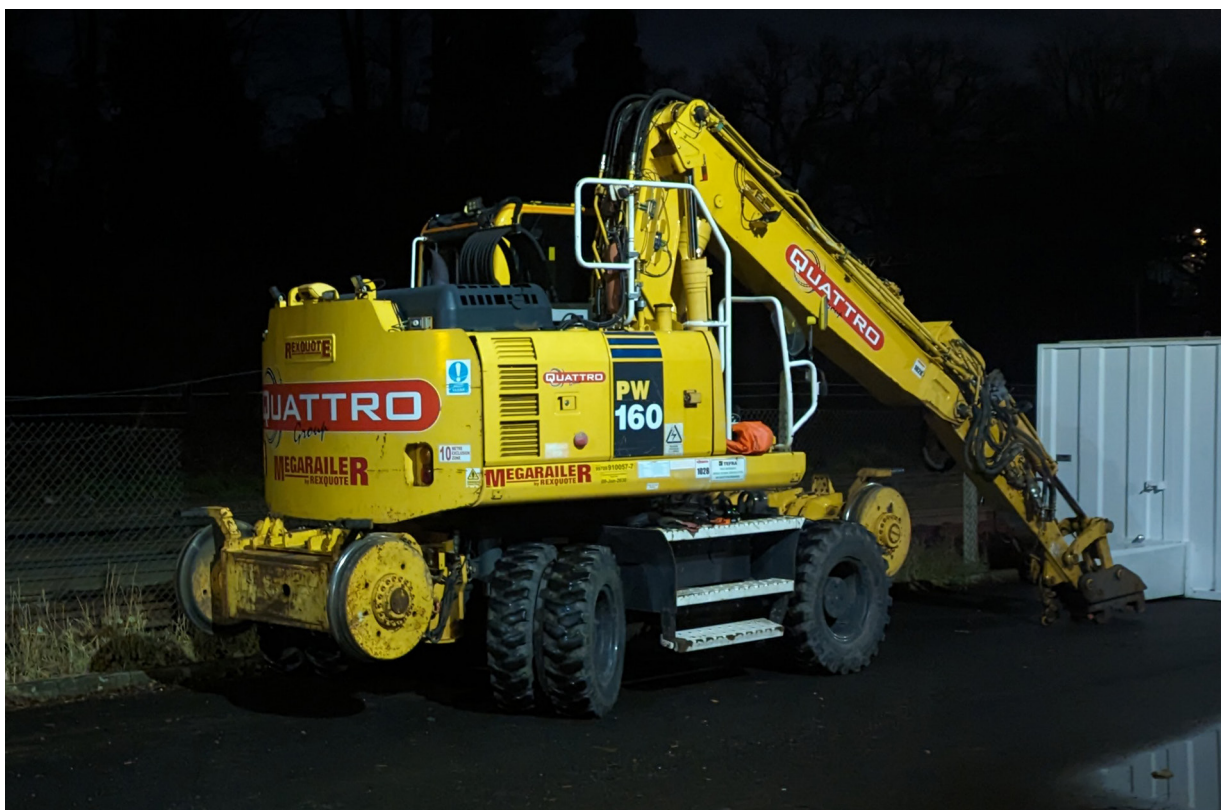
Figure 4: RRV used at the work site near Walton-on-Thames.

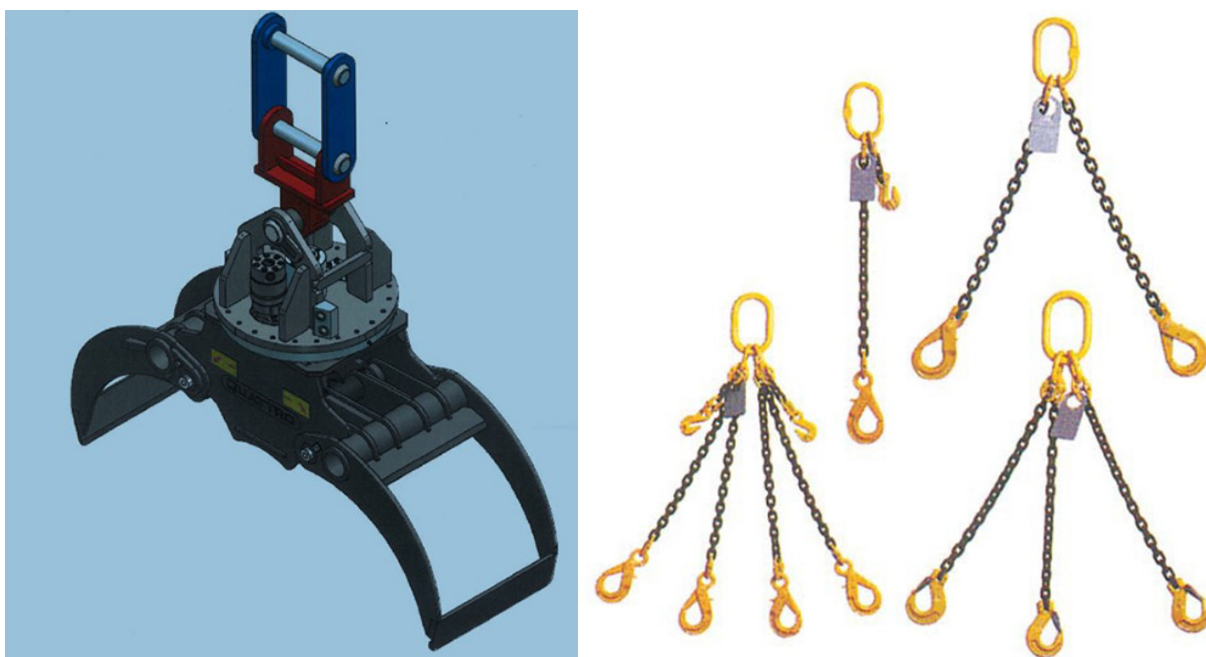
Figure 5: The left-hand image shows a schematic drawing of the type of log grab used at the work site near Walton-on-Thames and the right-hand image shows an example of the chains similar to that used.

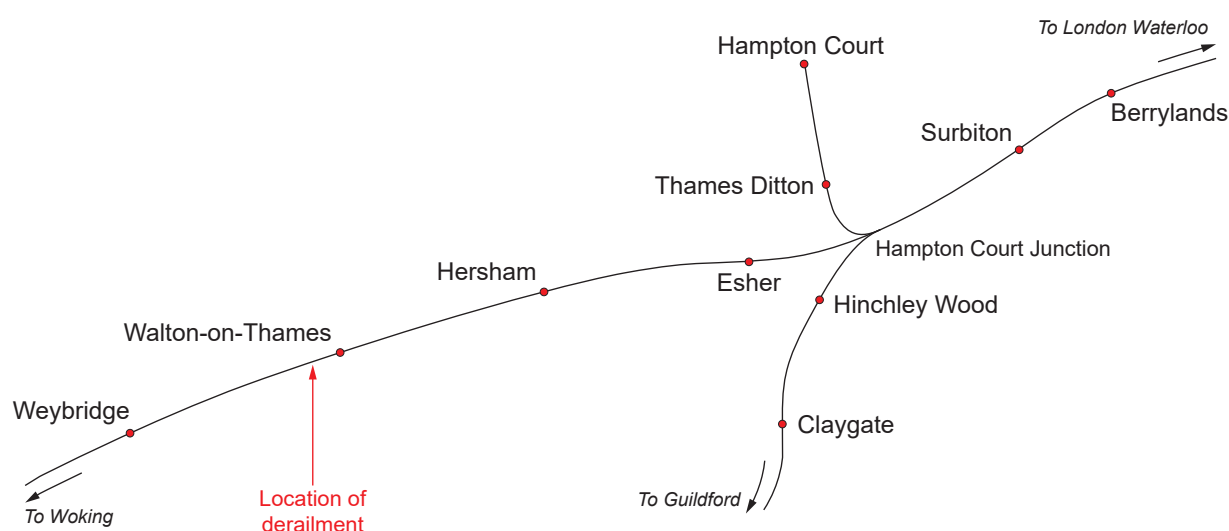
Figure 6: Overview of the location of the accident and nearby stations.

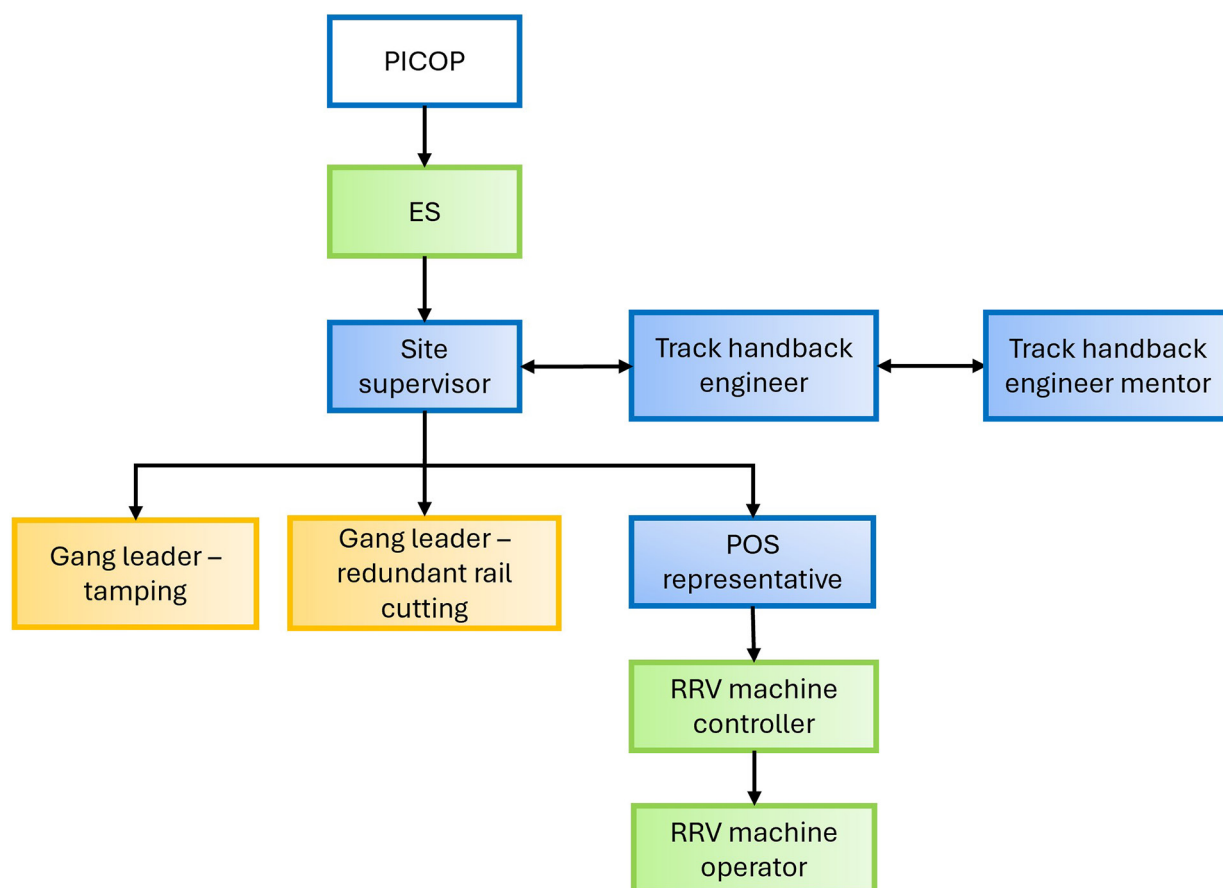
Figure 7: An organogram showing the reporting arrangements between the different staff involved in the work near Walton-on-Thames the weekend before the accident.

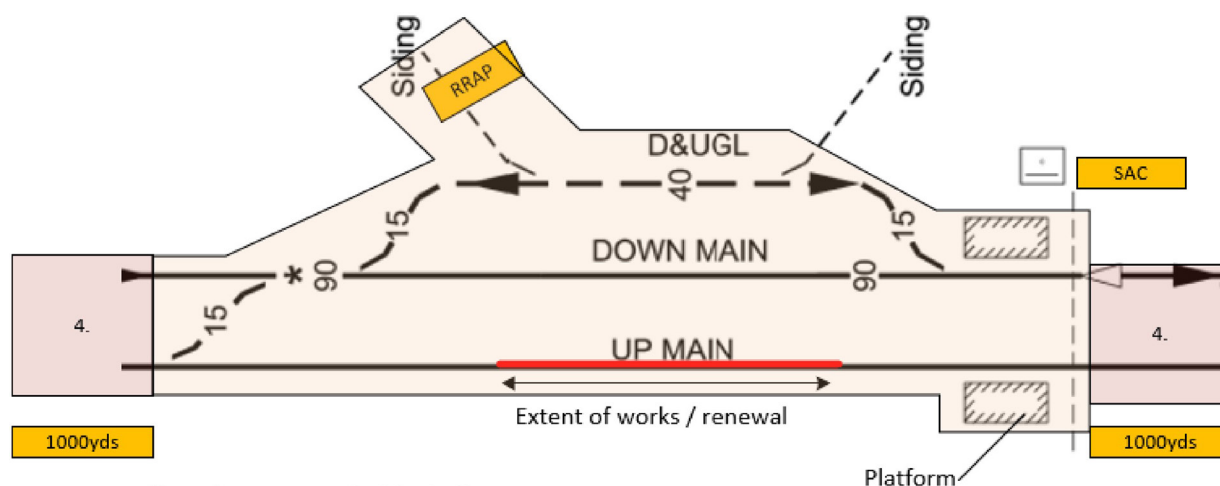
Affected Area Example (shaded):

1. RRAP: Used for on / off tracking machines in siding.
2. All tracks travelled by machines travel including through S&C to and from site.
3. Staff accessing / egressing through platforms from SAC may affect platform areas tidiness or materials left on the platform.
4. Track Handback Engineer to inspect 1000yds either side of affected mileage or upto marker boards – whichever is less.
